Application of bursting pressure and conventional drained behavioural theory to the Brumadinho failure

J A Wates

Keywords: tailings, upstreaming, bursting pressure, limit equilibrium, Brumadinho

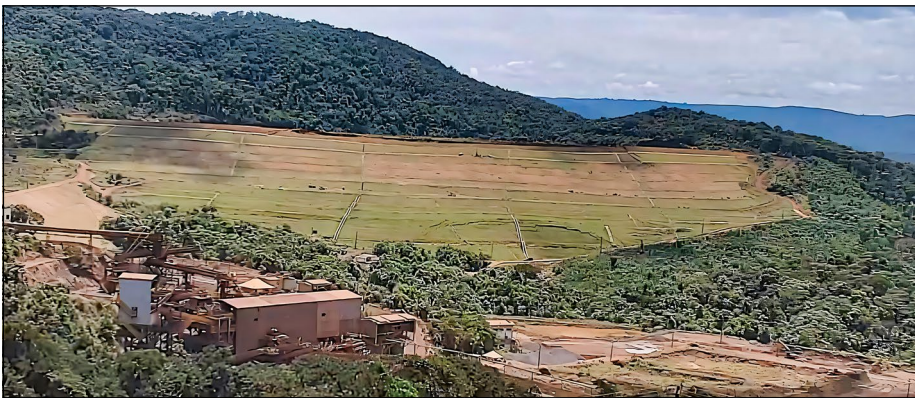
Image 2 Image of Brumadinho at onset of failure initiation (25 January 2019)

the crest and bulging of the face above the deepest point in the valley can be seen in the image. The section that best represents the weakest point in the embankment is Section 3 from the Expert Panel Report, as shown superimposed on Image 1. The cross-section at Section 3, on first examination, would not be considered to represent a risk since the overall drained factor of safety for a slope of 1v:3h, combined

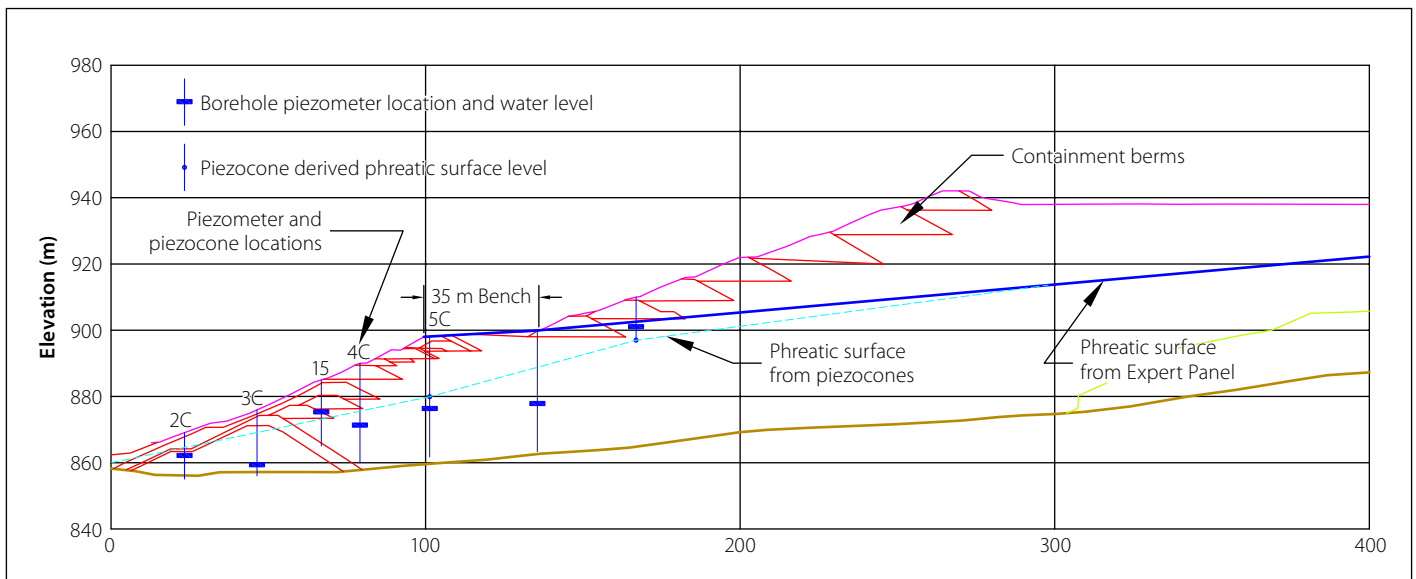
The Expert Panel Report established that the elevation of the phreatic surface at the time of failure was approximately coincidental with the bench at elevation 900 m amsl (shown in Figure 1 from Robertson *et al* 2019). The predicted phreatic surface

was found, by the Panel, to be realistic because of relatively poor foundation drainage and possibly poor performance of the drains that had been installed behind the starter embankment and subsequent raises. Actual piezometric levels and pressures derived from cone penetration test work (CPTu) are also shown in Figure 3 (see page 31) and illustrate a lower phreatic surface when compared to that predicted by the Expert Panel. Specifically, the piezometric and CPTu dissipation data give a relative consistent water elevation of about 878 amsl upstream of the starter wall.

Figure 1 Section 3 illustrating location of phreatic surface from the Expert Panel compared to measured piezometer and piezocone dissipation levels (figure modified from Robertson *et al* 2019)

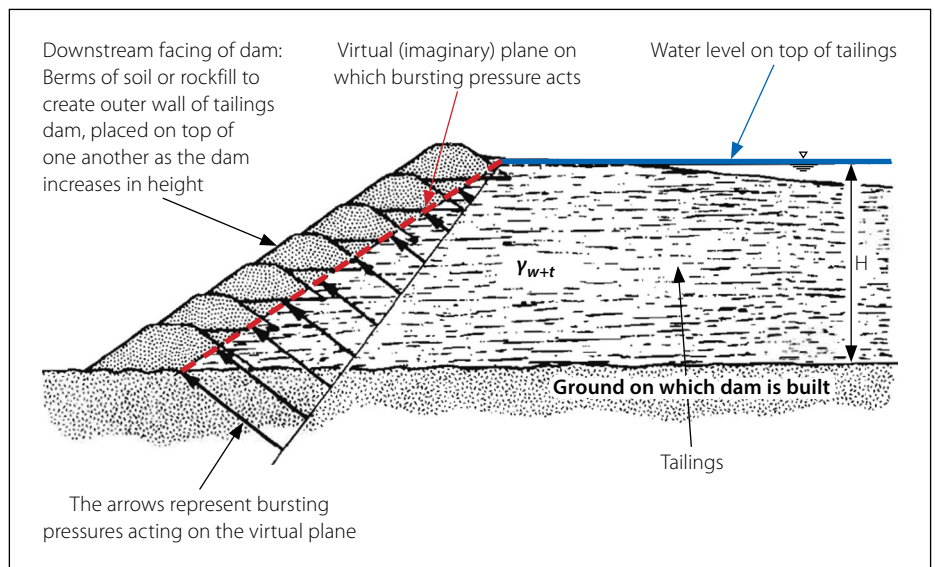
Figure 2 Illustration of bursting pressures by Casagrande and McIvor (1970) as adapted by the author in Wates (2023)

Casagrande and McIvor (1970) stated that the shell that provides resistance to failure of a tailings facility must be of sufficient width to retain “bursting pressures”. Casagrande and McIvor’s definition of a bursting mechanism is illustrated in Figure 2 (as adapted by Wates 2023).

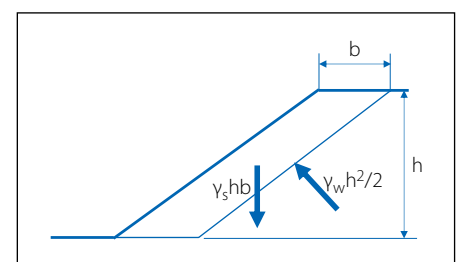
Figure 3 Representation of thrust that develops on face of relatively impervious embankments

to the product of the elevation difference between the free surface and the slice base multiplied by the unit weight of water. For the bursting mechanism the pressure is equal to the elevation difference between the point of exit of the phreatic surface and the base of the slice multiplied by the unit weight of water. Limit equilibrium analysis, using the method of slices, might therefore not correctly represent the Brumadinho case, since low permeability embankments may have allowed full hydrostatic pressure to build up behind the embankments (referred to as containment berms in the Brumadinho sections) if the drains were not fully functioning and adequately sized, or if drill holes were to introduce water into the drains at a rate faster than the water could be discharged. The equilibrium between the thrust (bursting pressure) arising from the hydrostatic pressure that exists behind relatively impervious embankments and the resisting mass is illustrated in Figure 3 on page 31.

In the configuration illustrated by Figure 3, the factor of safety against bursting failure (if the soil has no tensile strength) would be given by Equation 1.

For the Brumadinho section, for a factor of safety of one, using Equation 1, the width of the resisting wedge calculated for hydrostatic pressure behind the full slope up to the bench would be between 7 m and 10 m depending on the bulk density of the embankments. Locally, especially where the containment berms are narrowest, factors of safety could thus have been lower than one. The calculation therefore suggests that the stability of the bench could have been compromised by the increase in water pressure behind the containment berms that was brought about by the installation of DHP-15. The increase in pressure could thus have caused deformations (which were not visible on the surface at the time), and which in turn could have altered the stress regime within the tailings below the bench. The presence of excess water pressure is corroborated by the observation that water emerged about 7 m above the position of DHP-15 while it was

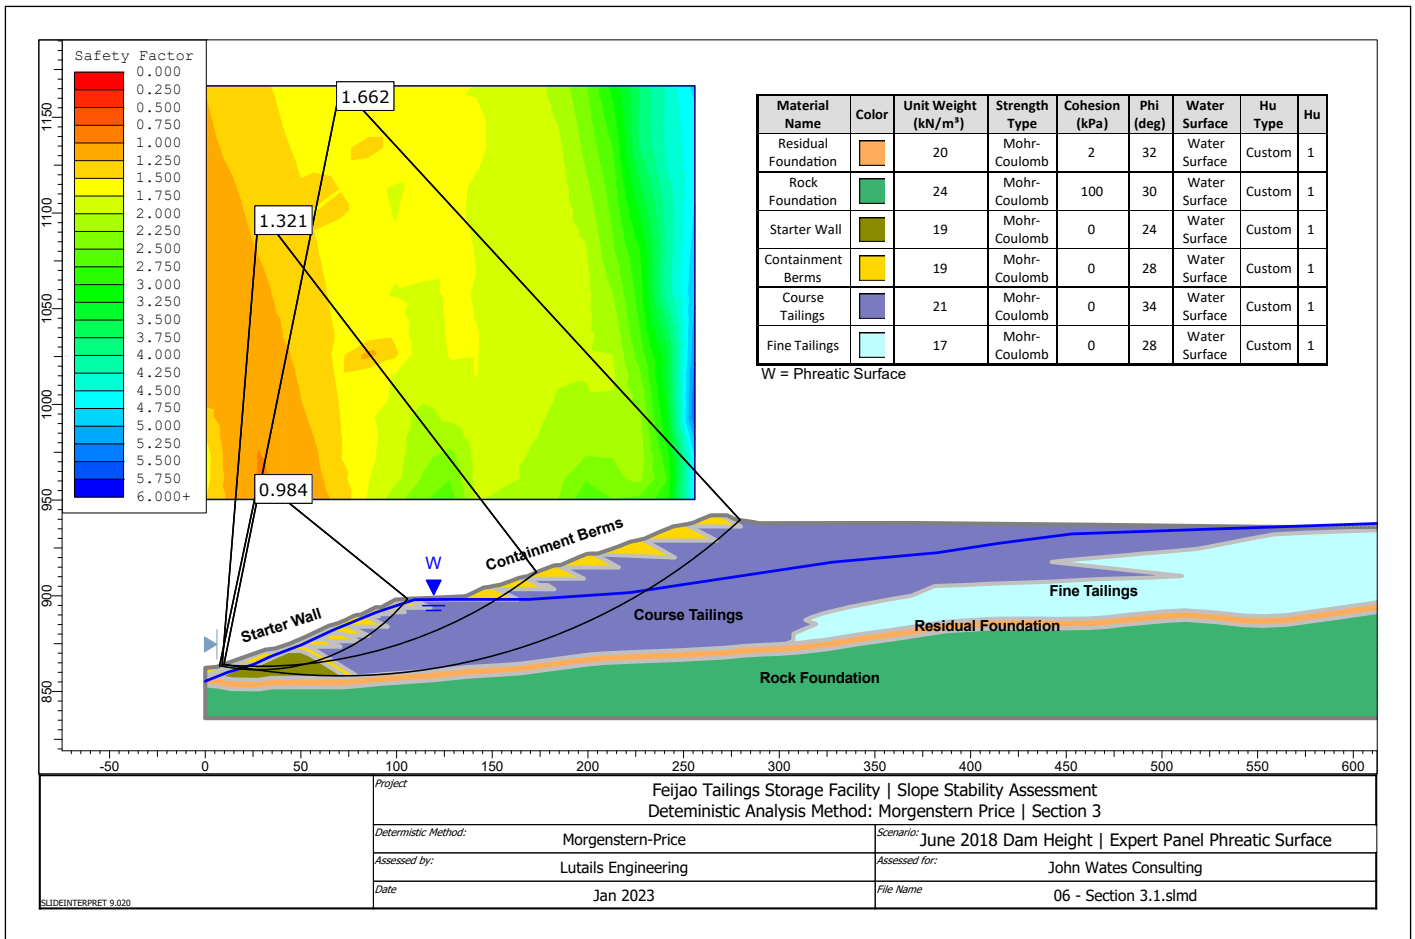
Figure 4 Shallow limit equilibrium result for bench and for full slope

The “bursting pressure” calculation has been compared with the conventional drained limit equilibrium analysis illustrated in Figure 4, using the Morgenstern Price model (Morgenstern 1965), which also shows that the factor of safety of the outer face of the slope below the bench would have been close to one.

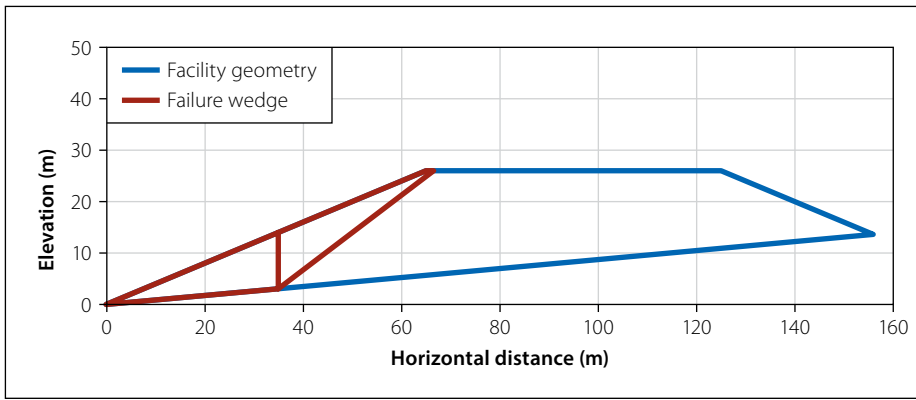
Equations to analyse the stability of a two-wedge translational failure mechanism proposed by Xuede *et al* (2003) were adapted to include a destabilising hydrostatic pressure acting along the failure scarp of the active wedge. This was done by assuming the hydrostatic pressure resulted in a horizontal and vertical force which could be incorporated into the force equilibrium equations used to obtain the factor of safety. The cross-section and two wedges assumed for the analysis are shown in Figure 5. This analysis also gives a drained factor of safety of about one for the Brumadinho slope geometry, assuming the water level is at the elevation of the first bench. This correlates well with the

Figure 5 Cross-section illustrating two wedge analyses using the Xuede *et al* (2003) limit equilibrium model

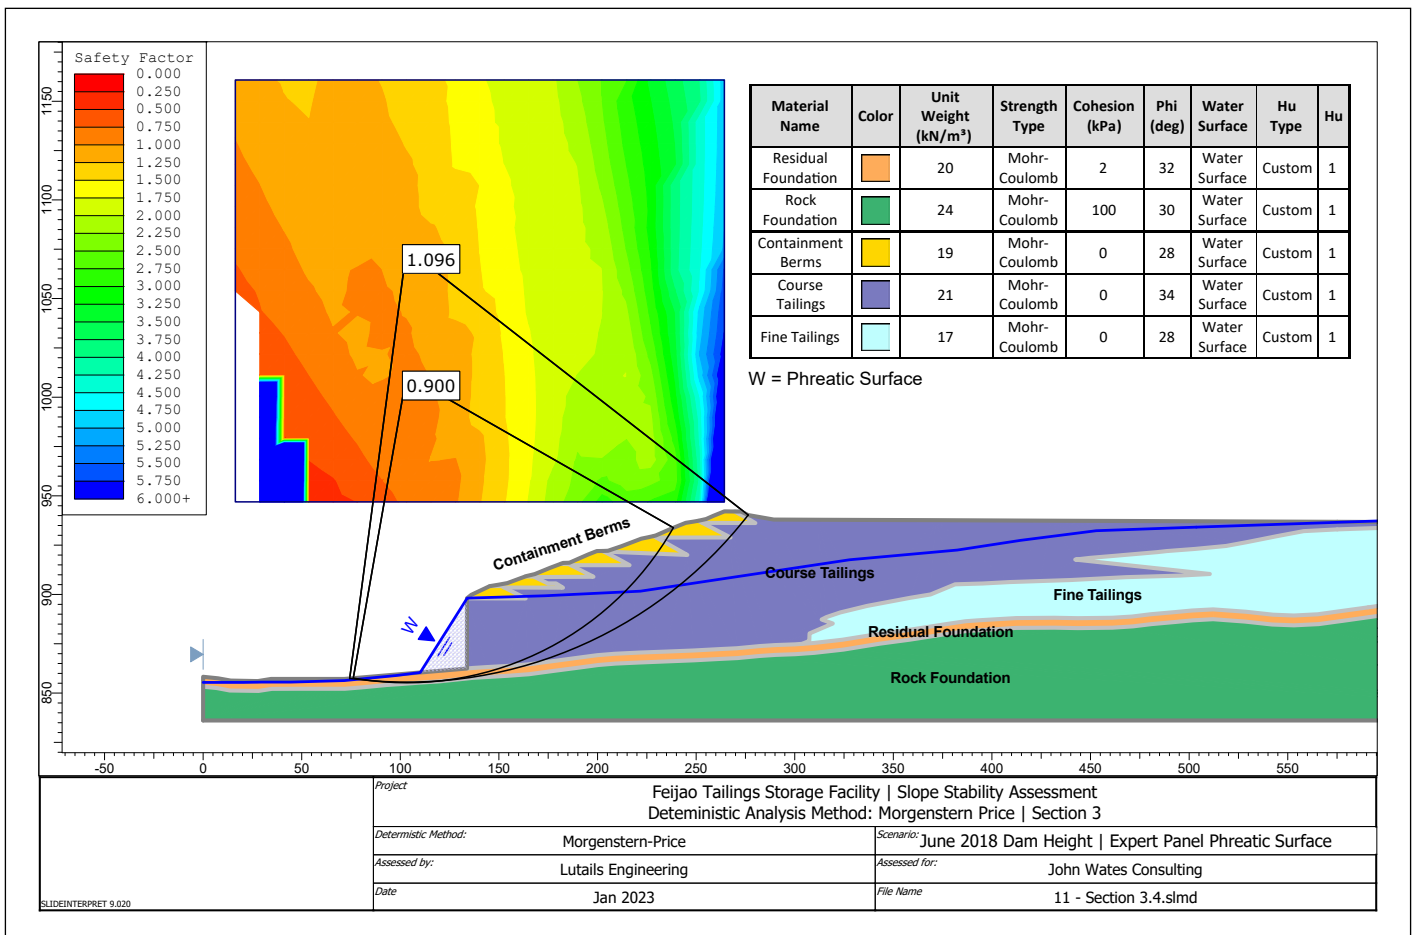
Since the video of the failure clearly shows that the full slope failed, the drained analysis of the bench (level 900 amsl) only suggests that the slope below the bench may have existed in a meta-stable state up to the time of the failure of the full slope. The impact that deformation of the slope below the bench could have had on overall instability was tested with a limit equilibrium model that assumed that the support from the slope up to level 900 amsl had been removed by assuming that this portion of the slope first failed (deformed) having a factor of safety of one or less. The results of this computation are shown in Figure 6.

The analysis suggests that the removal of support for the slope above the bench up to full height could have initiated a conventional drained failure at any time after the support had been removed. The removal of support could well also have led to the creep to which the Expert Panel attributed the failure.

Figure 6 Limit equilibrium result assuming removal of support of the slope below level 900

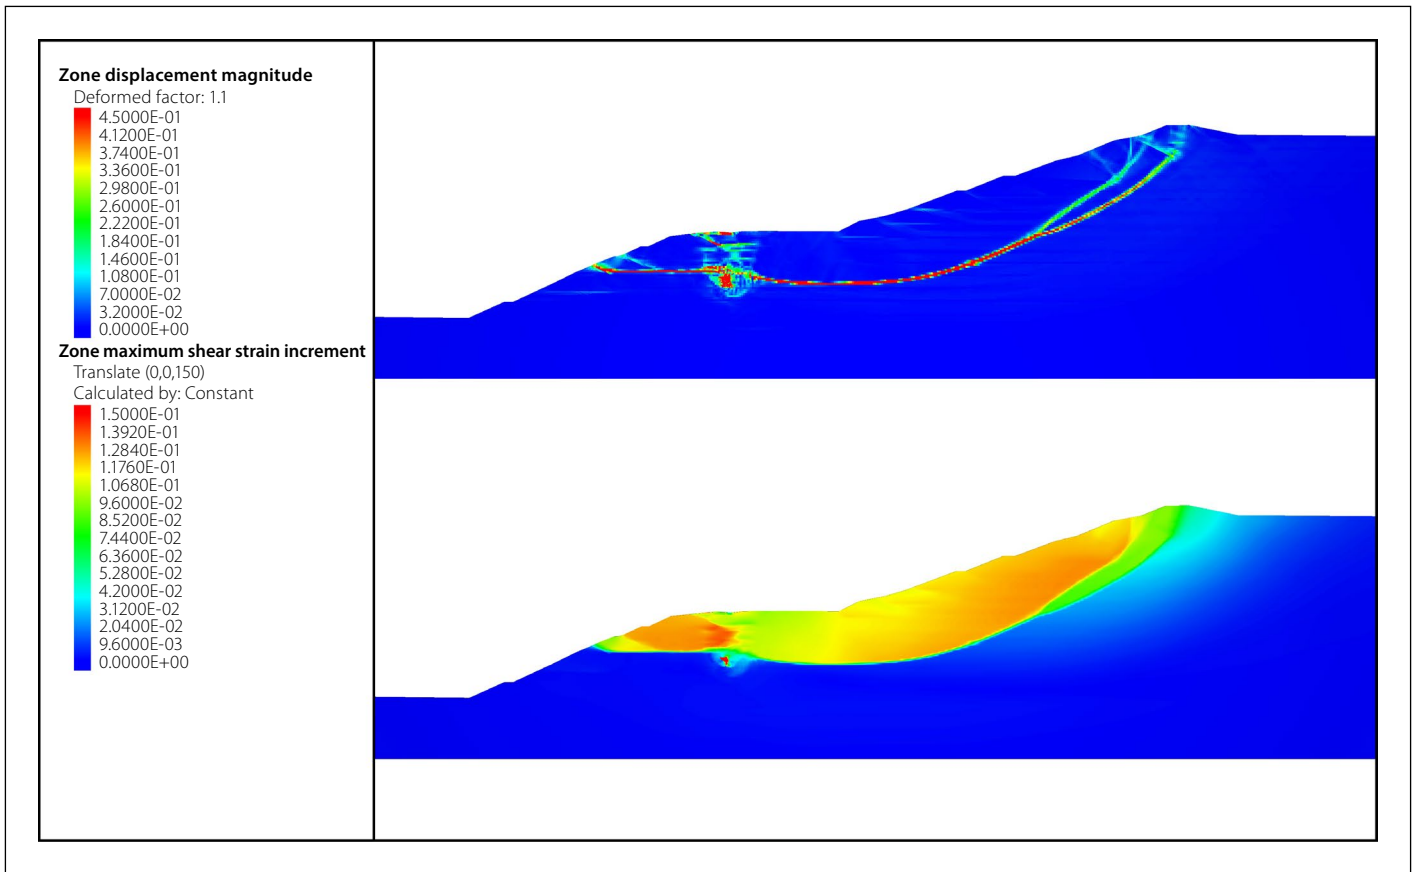
Figure 7 Displacement and shear strain results (video of progression of failure may be viewed on YouTube <https://youtu.be/-Wj23wiNBxs> or the ARC website <https://arq.co.za/?p=2656>)

At the end of the staged construction, the void was introduced with a water pressure applied to the void surface. The position of the void is shown in Figure 7 where the stress concentration is initiated (the red zone). The model converged here, indicating that it was stable under these conditions. The water pressure applied to the void surface was then removed and zones with a high strain rate were switched to an undrained state. This resulted in the global failure for the 2 m diameter cavity shown in Figure 7.

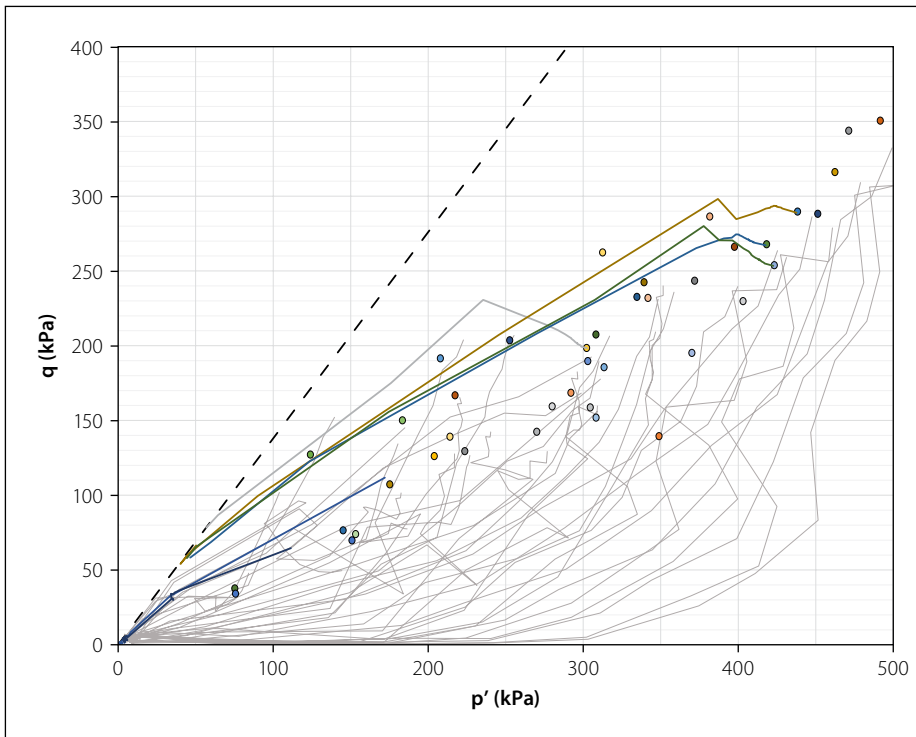
Figure 8 provides the stress paths for development of the facility for selected points with the dots indicating the stress state when the void is introduced with water pressure still applied, and the colour

Figure 8 Stress paths in $p':q$ projection

paths show the stress development of a few of the queried points which fall on the shear zone of the failure once the water pressure is removed. All experience a decrease in mean effective stress and loss of strength, and the paths all move towards the CSL (black dashed line). The plots in the $e:p'$ projection confirm undrained behaviour in the zones as there is no change in void ratio and confirm that realistic results have been obtained from the analysis.
