# Correlations of geotechnical monitoring data in open pit slope back-analysis – A mine case study

Correlations of geotechnical monitoring data in open pit slope back analysis – A mine case study.

Journal of the Southern African Institute of Mining and Metallurgy, vol. 121, no. 10, pp. 557–564

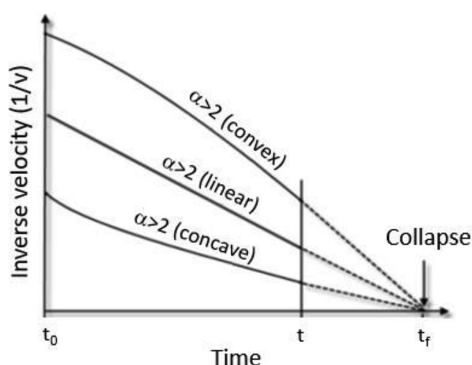
In addition, Fukuzono (1985) proposed an inverse method that consists of calculating the rate of deformation (velocity) of a slope and plotting the inverse of the rate of deformation as a time function (inverse velocity *versus* time). This technique has been mentioned frequently in the literature (Rose and Hungr, 2007; Osasan and Stacey, 2014; Intrieri and Gigli, 2016). As the velocity or rate of deformation increases, the inverse will tend towards zero. With the use of linear regression, the intersection with the horizontal axis can be obtained; this intercept represents the expected time of collapse (Figure 1).

Figure 1—Inverse velocity *versus* time prior to slope failure (Fukuzono, 1985)

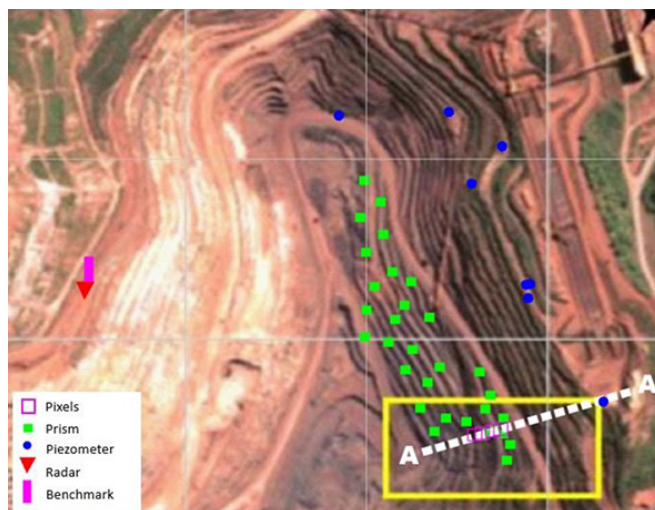
The investigated slope is situated on the east wall of the open pit. In 2017, a failure occurred, involving approximately four benches and the mass movement of material to lower benches. The affected area is shown within the yellow rectangle in Figure 2.

Figure 2—Distribution of instruments and location of section A-A

Figure 2 illustrates the location of the instruments on the east flank of the central pit and the section utilized for the back-analysis. The differences in the topography before (28/02/2017) and after (30/03/2017) the event were considered to define the failure surface with the highest possible precision.

To calibrate the displacements, the pixels imaged along the critical section (Figure 2) were chosen, and their behaviour (trends, cycles, and oscillations) analysed according to the date available prior to the failure. The radar operates using the phase variation between two scans. These measurements are applied to calculate the displacement of the slope surface; the displacement vector is not used for prism monitoring. Table IV presents information about the pixel size, distance to the radar, and values measured at a time near collapse.

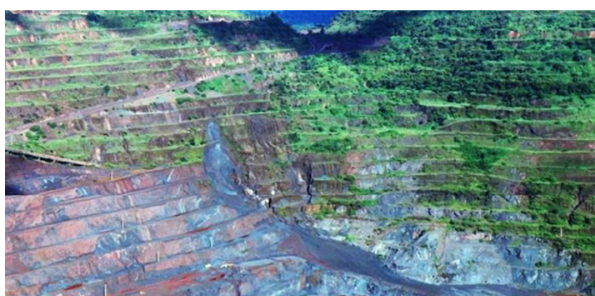
The failure mode was considered planar/circular, with the mechanism developed in the contact between friable materials, the friable haematite (HF) with high permeability, and MD that exists along the entire eastern flank, which is a very low permeability material. The failure surface extended over a height of approximately 60 m. Figures 3 and 4 show the situation before failure and after failure, respectively.

Figure 3—Open pit before failure (February 2017)

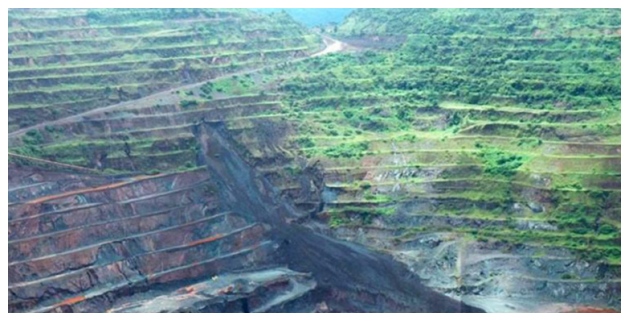
Figure 4—Open pit after failure (March 2017)

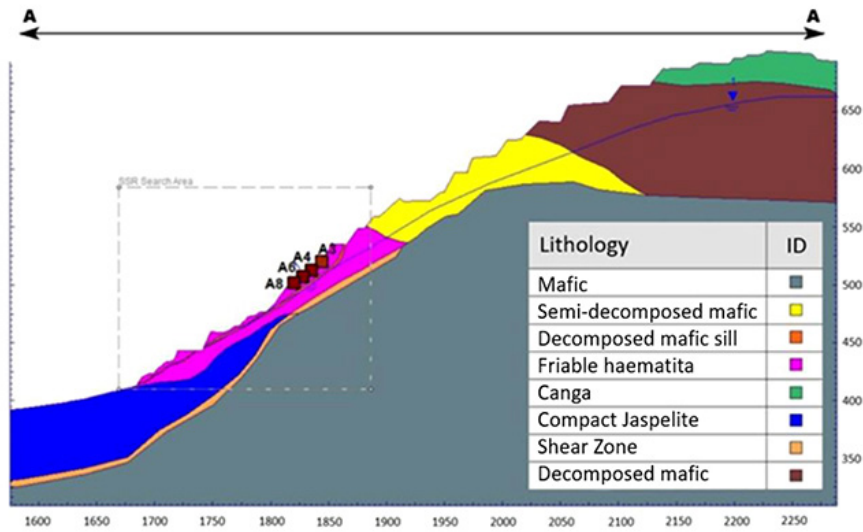
Figure 5 presents the critical section modelled with the materials in the study area, namely the data obtained through geotechnical mapping and field observations. The failure surface, with a thickness of approximately 2 m, is defined, involving the

contact between the HF and the MD, with the latter playing a significant role in the failure process. The contact between the materials was modelled taking into account the geological model, geotechnical mapping, and field observations after failure.

Figure 5—Localized pixels along the critical section

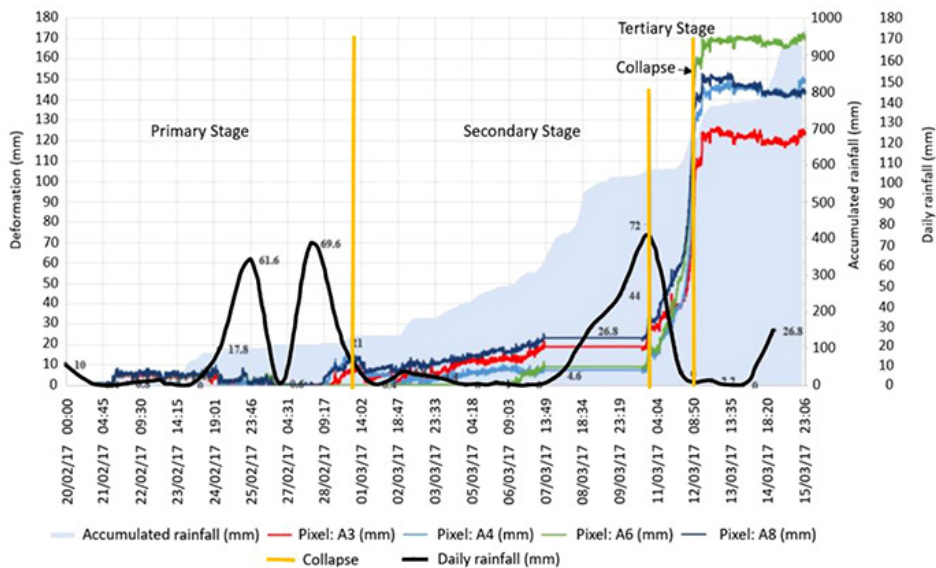
The rain that fell on the previous days (a daily amount of 72 mm) contributed to the triggering of the failure, enabling movement accelerations on 11/03/2017 and 12/03/2017, as shown in the graph in Figure 6.

Figure 6—Displacement stages

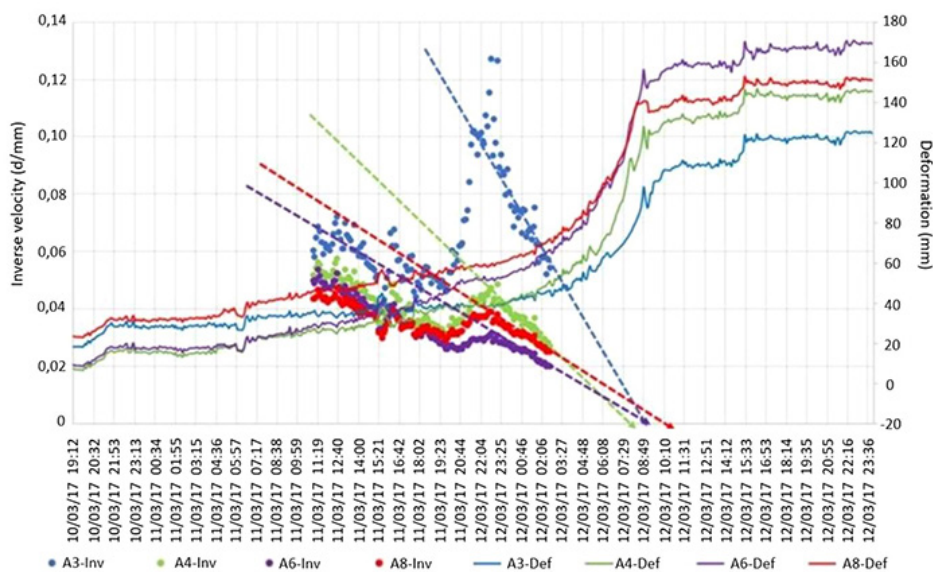
Figure 7 demonstrates that the deformation started to change at approximately 05:00 on 03/12/17, with a tendency to collapse between 08:49 and 11:30, a forecast very close to the actual time of failure.

Figure 7—Deformation measurements, inverse velocity technique, and collapse prediction

The deformation rates in this short period were so high that, in less than 4 hours from the onset of acceleration, the rock mass lost its strength, causing the slope to fail.

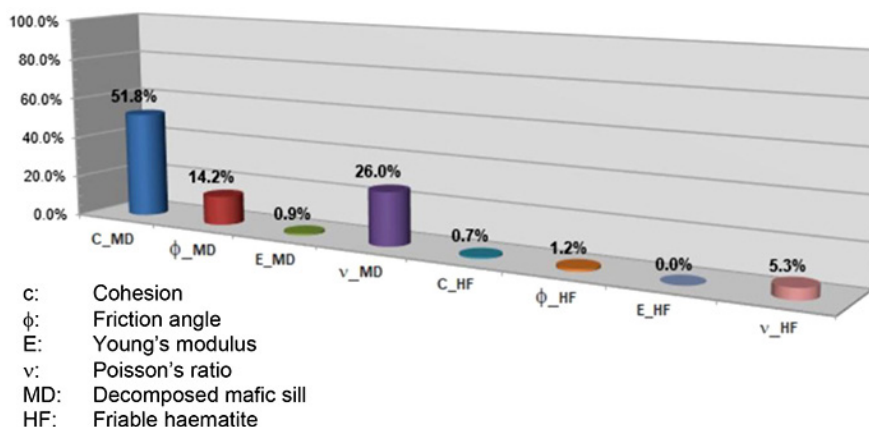
The results obtained from the back-analysis and statistical data show that the variables (parameters) with the greatest contributions to the failure were the cohesion, friction angle, and Poisson's ratio, which influenced the MD (approximately 93%) more than the HF (Figure 8).

Figure 8—Contributions of the parameters in the instability

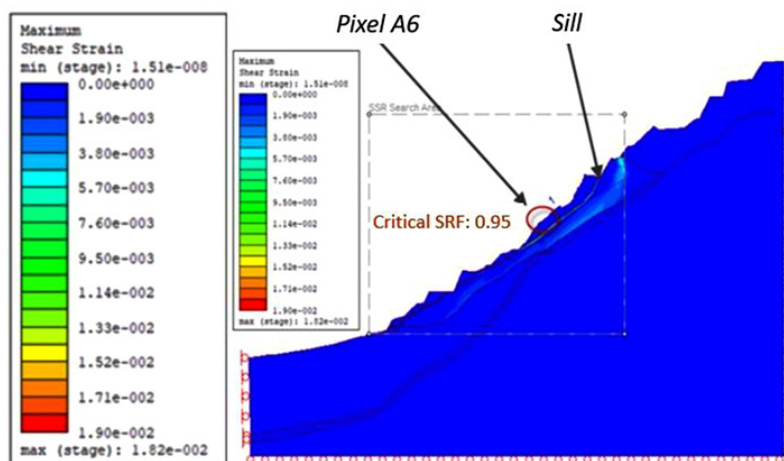
Figure 9 presents the critical section analysed with the calibrated parameters, failure surface defined in the sill, and area where the displacements initiated the collapse.

Figure 9—Maximum deformations in the calibrated section

The maximum displacements were observed at pixel A6, with a calculated displacement of 153.79 mm and measured displacement of 156.281 mm, thereby defining the region with the greatest acceleration. The collapse originated in this region.
