Fracturing of rock ahead of the face of an excavation and its relevance to mechanized excavation

by M. Mokgohloa¹ and T.R. Stacey²

Mokgohloa, M. and Stacey, T.R. 2024. Fracturing of rock ahead of the face of an excavation and its relevance to mechanized excavation. *Journal of the Southern African Institute of Mining and Metallurgy*, vol. 124, no.11 pp. 653–660

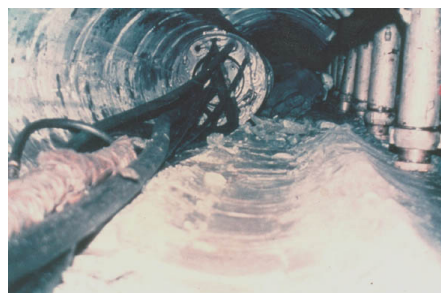
Figure 2—Stope coring of gold reef

During experimental mechanized mining of gold reef by stope coring (Stacey, 1982b), shown in Figure 2, it was found that the rock being cored 'burst' spontaneously within the 600 mm diameter core barrel.

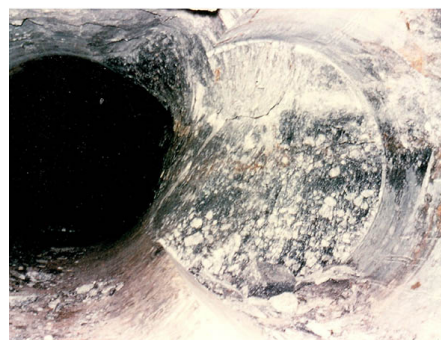
Figure 3—Exposed face of a stope corer hole

Figure 3 shows the face of a Stopecorer hole after face bursting, exhibiting a clean extension fracture surface. During one of the phases of the experimental coring programme, about an hour after coring in the first hole to be drilled, a 'disc', involving the full diameter, suddenly 'burst' very audibly off the face. This occurrence correlates with the observation of a fracture occurring ahead of the face of the Atomic Energy of Canada Limited (AECL) tunnel described by Martin (1997).

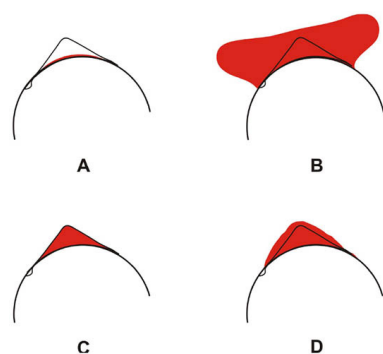
Figure 7—Failure extent predicted by alternative criteria. (A: observed geometry; B: Mohr Coulomb; C: Extension strain; D: Cohesion-weakening-friction- strengthening)

A further example is the well-published AECL tunnel in Canada (Martin et al, 1997), which, although not a bored tunnel, did not involve excavation by blasting. This is a high-quality case study since the parameters are well known: the rock strength parameters and the in situ stresses, as well as the history of fracture and failure development. Breakout development was modelled using alternative failure criteria. The observed breakout geometry was matched well using the cohesion weakening friction strengthening criterion (Hadjiabdolmajid et al., 2002), as shown in Figure 7, but this also indicated failure on the sub-horizontal axis, which did not occur. The Mohr-Coulomb prediction was completely incorrect. Wesseloo (2000) modelled the development of the breakout, using a finite difference numerical analysis stepwise approach, applying an extension strain criterion (Wesseloo and Stacey, 2000). Zones adjacent to the surface, indicated as failed after each step, using the criterion, were nulled to simulate fallout of spalling rock. The predicted development of the breakout eventually stabilized, and its final geometry matched the observed geometry, as shown in Figure 7.

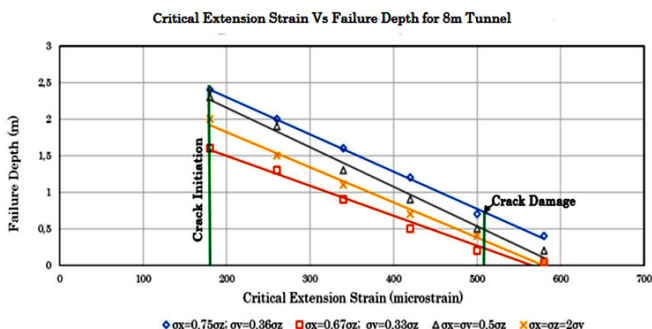
Figure 9—The predicted failure depth for different stress ratios for an 8 m diameter tunnel (Poisson's ratio 0.2)

The relationships between the predicted maximum failure depths around an 8 m diameter tunnel and the critical extension strains are shown in Figure 9. This indicates the sensitivity of the in situ stress ratios and the critical extension strains. Both crack initiation and crack damage points are indicated on the graphs. As can be expected, since the analyses were elastic, there is a linear relationship between predicted depths of fracturing and values of the critical extension strain, and the tunnel size. This implies, confirming experience, that a smaller diameter tunnel is less likely to cause boring problems than a larger diameter tunnel.

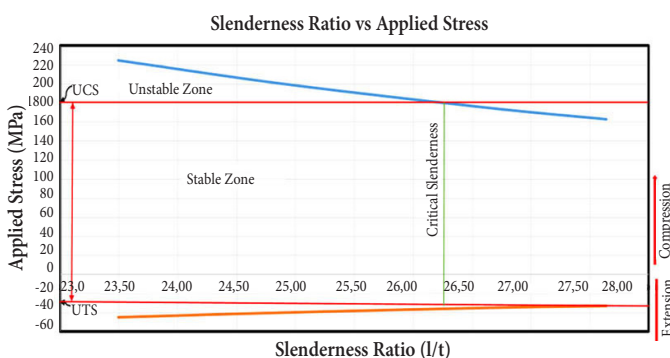
Figure 14—Determination of critical slenderness ratio for buckling analysis under eccentric load

Application of these formulae yields the results in Tables V and VI, and Figures 14 and 15, assuming eccentricity (e) of $t/4$. It can be seen that potential buckling can be predicted when the slenderness

ratio is 26.2 or less, indicating that the compressive strength has been exceeded. This area is indicated as an unstable zone. The zone within the limits of UCS and uniaxial tensile strength (UTS) denotes stability, as can be seen in both Figures 14 and 15.

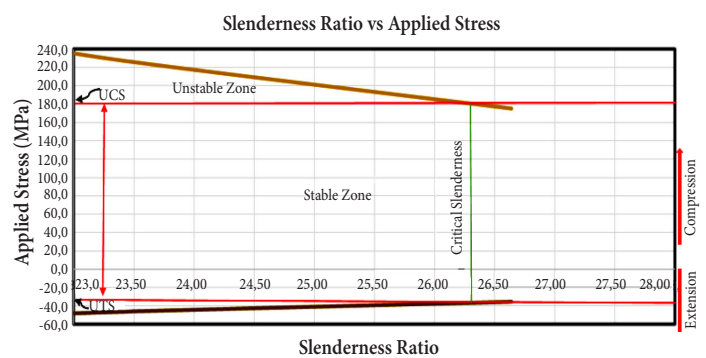
Figure 15—Determination of critical slenderness ratio for buckling analysis under eccentric load
