Effects of tailings disposal on the environment: A case study of Nampundwe Mine

Nalukui, S. and Besa, B. 2024. Effects of tailings disposal on the environment: A case study of Nampundwe Mine. *Journal of the Southern African Institute of Mining and Metallurgy*, vol. 124, no. 9. pp. 527–534

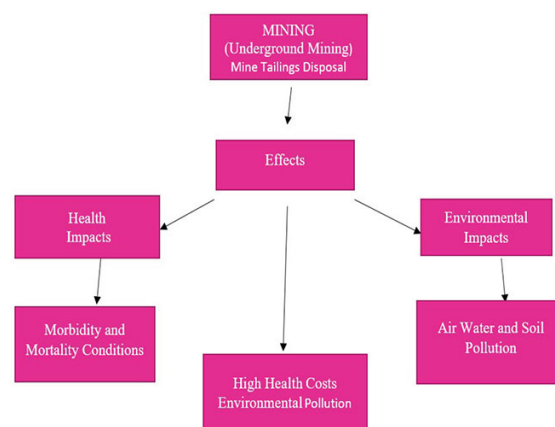
The conceptual framework (Figure 2) used for the study illustrates the environmental and health impacts of mine tailings disposal on the environment. It shows the impact of mine tailings disposal on the environment and the health of people, according to the available literature.

Figure 2—Conceptual framework illustrating mine tailings disposal, environmental, and health impacts

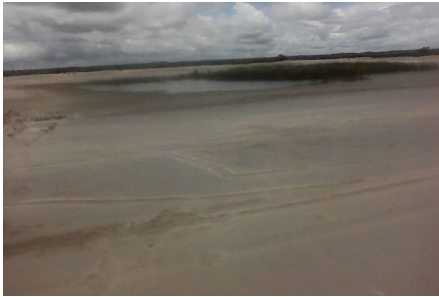
1998). At Nampundwe mine, the tailings are pumped as slurry to the tailings dam situated 700 metres to the south of the plant. The slurry is discharged from a spigot that is moved around the perimeter of the facility and the walls are raised using the tailings.

Figure 3—The tailings dam storage facility at Nampundwe mine

According to Vick, (1983), the disposal of tailings is commonly identified as the single most important source of environmental damage by any mining operations. This is not surprising when considering that the volume of tailings requiring storage can often exceed the in-situ total volume of the ore being mined and processed. Over the last century, the volumes of tailings being generated at Nampundwe mine have increased dramatically as the demand for minerals and metals has enlarged. Nampundwe mine tailings are frequently stored in tailings dams, also known as tailings storage facilities, indicated in Figure 3.

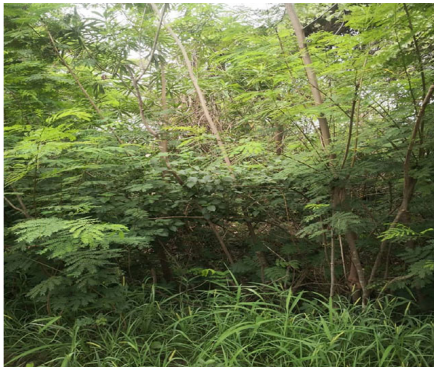
Prevention and control of surface runoff from the plant area to the surrounding environment and minimizing dust generation are important considerations for the receiving environment illustrated at Nampundwe mine in Figure 4.

Figure 4—Trees planted around the tailings dam for dust minimization

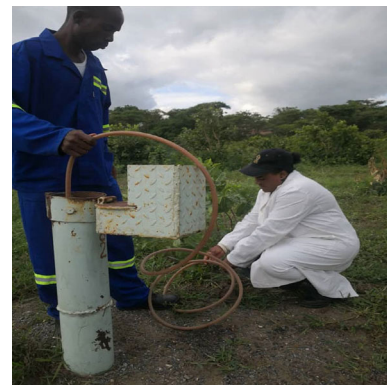
There are four (4) monitoring boreholes around the tailings dam, which are used by the company to monitor the level of contamination from the tailings dam. The water quality monitoring data collected indicated that the pH level was between 7 and 8, sulfate presented an average of 445–505 mg/l, iron 0.8, and other dissolved metals were present at low concentrations. Water samples were also collected from the monitoring boreholes around the Nampundwe mine (Figure 7).

Figure 7—Water sample being collected from one of the monitoring boreholes

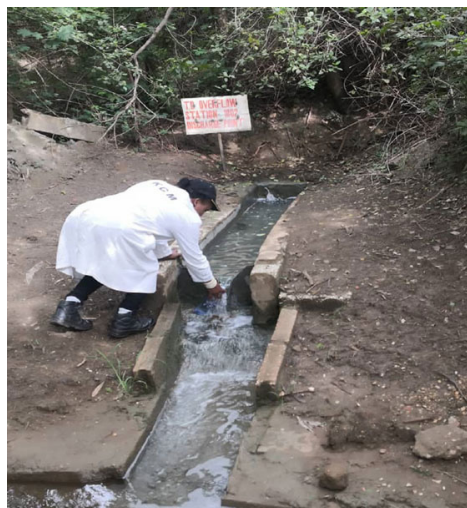
Figure 8 shows the over-flow water from the tailings dam at Nampundwe mine. The overflow water is released into the Kacheta stream through the toe drain. There are filter drains installed in the dam walls, which also flow to the decant drain. One (1) water sample was collected from the tailings dam overflow/decant drain to determine the quality of water discharged into the water system from the tailings dam. The water quality monitoring data collected indicated that the pH level was between 7 and 8, sulfate exhibited an average of 1011 mg/l, iron 0.1, and other dissolved metals were present at low concentrations.

Figure 8—The decant or the overflow from the mine tailings storage at Nampundwe mine

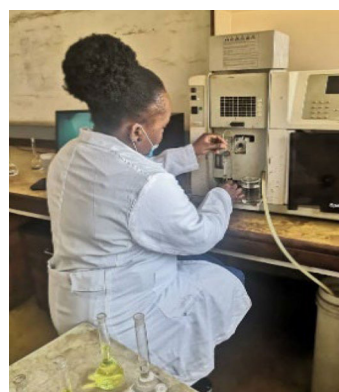
Water and soil samples were analysed by means of the Atomic Absorption Spectrometer (AAS) at the University of Zambia, School of Mines Geo-Chemical Analytical Laboratory (Figure 10). The AAS is a tool that was used to analyse the metal concentration

Figure 10—Sample analysis

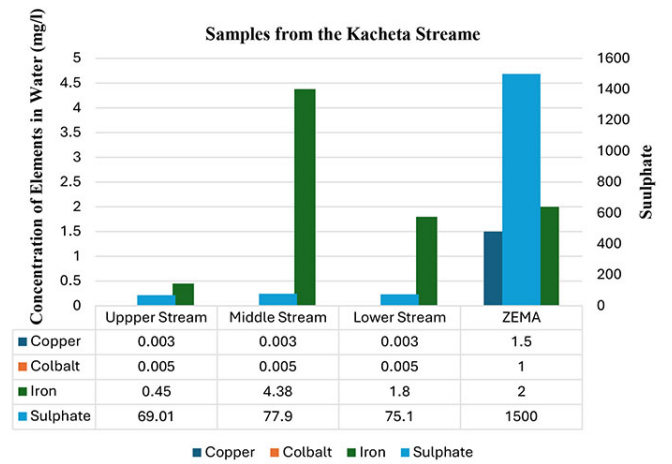
According to water sampling results (Figure 11), it is evident that all element concentration levels from all the samples tested and analysed were below the ZEMA statutory limits. However, iron was recorded at 4.38 mg/l in the middle of the Kacheta stream. The iron concentration exceeded the statutory limit of 2.0 mg/l. The pH level ranged between 5.5 to 6.8, whilst the TDS levels were between 1300 mg/l to 1500 mg/l. The water quality monitoring data collected indicated that the pH level was between 7 and 8, Sulfate exhibited an average of 445-505 mg/l, whilst other dissolved metals were present in low concentrations.

Figure 11—Concentration of elements from the Kacheta stream

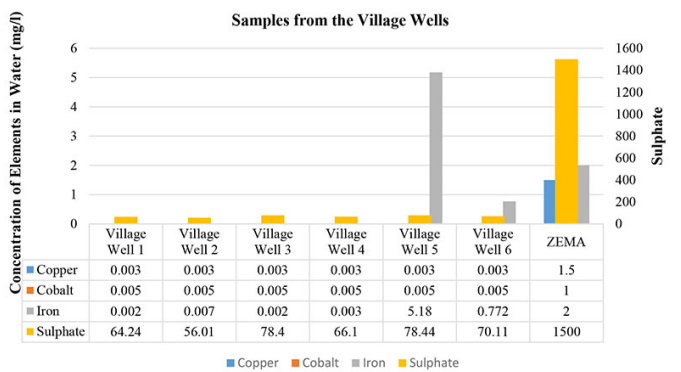
In addition, it was found out that all element concentrations recorded from all the village wells sampled, were below the ZEMA statutory limits (Figure 13). However, iron exhibited a higher concentration of 5.18 mg/l, which was in excess of the ZEMA statutory limit of 2.0 mg/l. The higher concentration was also attributed to the natural formation of iron within the Nampundwe area, and the depth of the wells being in a range of 10 metres to 25 metres, where the land has a slight slope and the distance is 0.5 km to 3 km far from the tailings storage facility (TSF) respectively.

Figure 13—Concentration of elements from the village wells

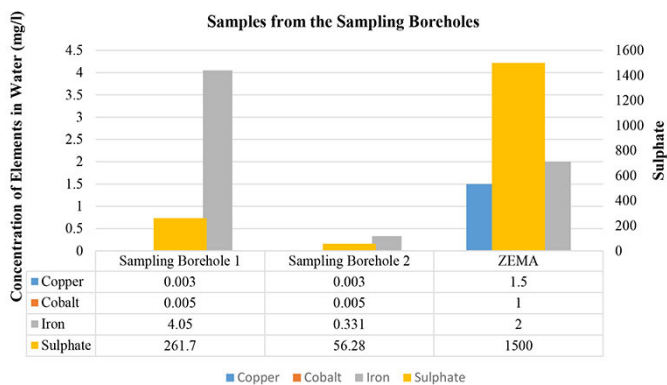
Additional findings indicated that the concentration of all the elements recorded (Figure 15) was below the ZEMA statutory limits, except for iron, which recorded 4.05 mg/l from the sampling borehole 1. The concentration recorded was higher than the ZEMA statutory limit of 2.0 mg/l, but it was also attributed to the naturally

Figure 15—Concentration of elements from the sampling boreholes

occurring element present in the Nampundwe area. The depth of the boreholes was in a range of 30 metres to 90 metres, where the land has a slight slope. There are monitoring boreholes around the tailings storage facility (TSF) to monitor the amount of element concentration that could be present within a distance of 0.5 km to 1.5 km far from the TSF, respectively.

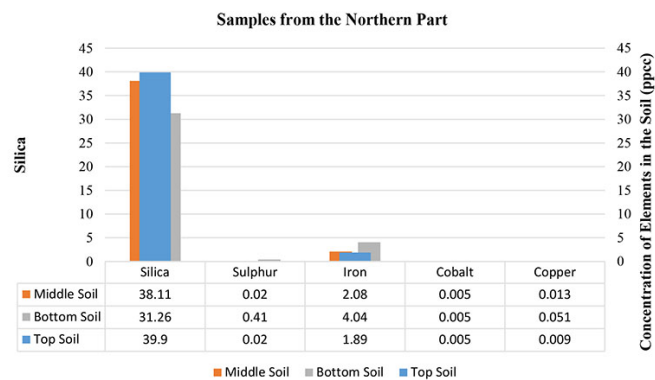
Figure 16—Concentration of elements in the soil from the northern part

Sampling results revealed that the soils in the Nampundwe area exhibited the presence of Sulfur, iron, and silica. In relation to Figure 16, silica represented the highest concentration as compared to other metals because the wind was blowing in the northern direction of the tailings at the time of sampling. In addition, the particles were being moved in a northern direction by the running water resulting from the rains. All the levels of soil from the northern part of the tailings recorded the presence of silica, Sulfur, and iron as shown in Figure 16.

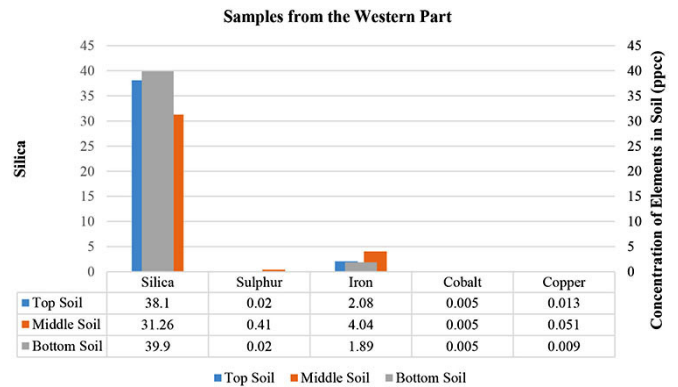
Figure 17—Concentration of elements in the soil from the western part

In the western part of the tailings, results in Figure 17 show that silica and iron were present in all the levels of soil.

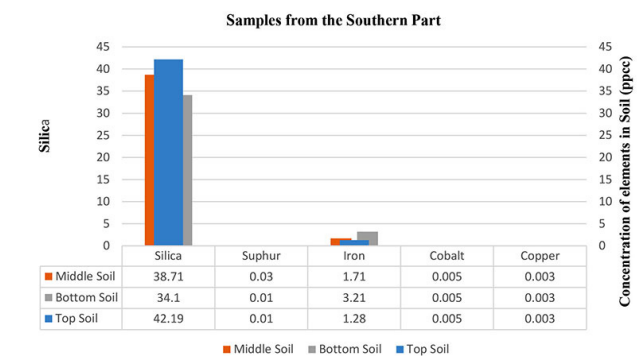
Figure 19—Concentration of elements in the soil from the southern part

The southern part of the tailings recorded concentrations of silica and iron in all the levels of the soil as can be seen in Figure 19.
