Application of bursting pressure and conventional drained behavioural theory to the Brumadinho failure

J A Wates

Keywords: tailings, upstreaming, bursting pressure, limit equilibrium, Brumadinho

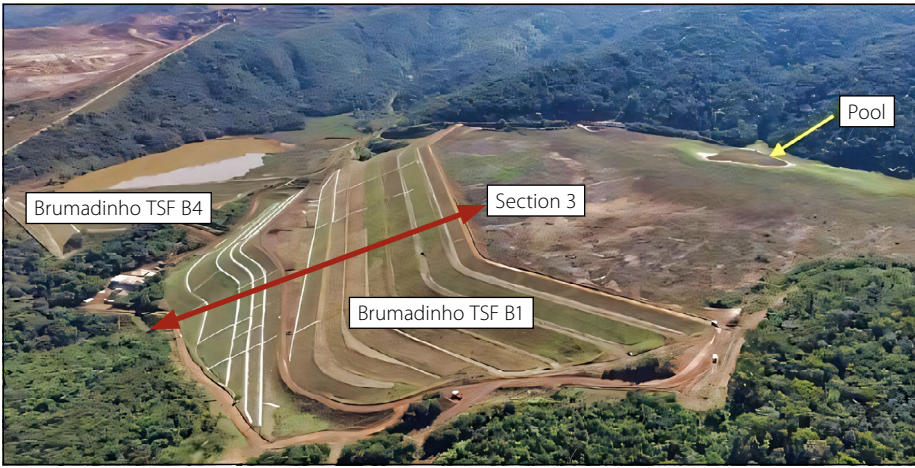
An aerial view of the Brumadinho facility before it failed is shown in Image 1. The facility was approximately 86 m high when deposition ceased in 2016 and contained approximately 12 million m³ of tailings. The face of the Brumadinho tailings facility, as it began to fail on 25 January 2019, is shown in Image 2 (a video of the failure may be viewed at <https://g1.globo.com/mg/minas-gerais/noticia/2019/02/01/video-mostra-o-momento-exato-em-que-barragem-da-vale-rompe-em-brumadinho.ghtml>). The slumping of most of

Image 1 Aerial view of the Brumadinho tailings storage facility (TSF) in 2018 before failure

the crest and bulging of the face above the deepest point in the valley can be seen in the image. The section that best represents the weakest point in the embankment is Section 3 from the Expert Panel Report, as shown superimposed on Image 1. The cross-section at Section 3, on first examination, would not be considered to represent a risk since the overall drained factor of safety for a slope of 1v:3h, combined
