The earthquake acceleration and resulting filtered displacement time histories used in the experiments are discussed. The sequence of earthquakes, as well as the base harmonic motions, applied to the test structure is specified. The results in the form of damage observed and typical measured displacements and accelerations are presented. The maximum values from each earthquake event are tabulated. The resulting damage and recorded motion are then discussed. The earthquake load testing is compared with design code response spectra requirements. The paper concludes by summarising the findings and identifying limitations that need to be addressed in further research.

A full-scale 3,9 x 3,9 m dry-stack masonry structure, 2,76 m high, shown in Figures 1a and 1b, was built on the shake table. The masonry block dimensions were: 220 x 230 x 115 mm. This structure corresponds to a single room, constructed according to the requirements of Hydraform (2009). In general, such a room could be part of a larger dwelling, e.g. (a) four such rooms in an 8 x 8 m house or (b) multiple 4 x 4 m rooms connected in a line. A standard doorway (2,07 x 0,813 m) was introduced on two adjacent walls (north an

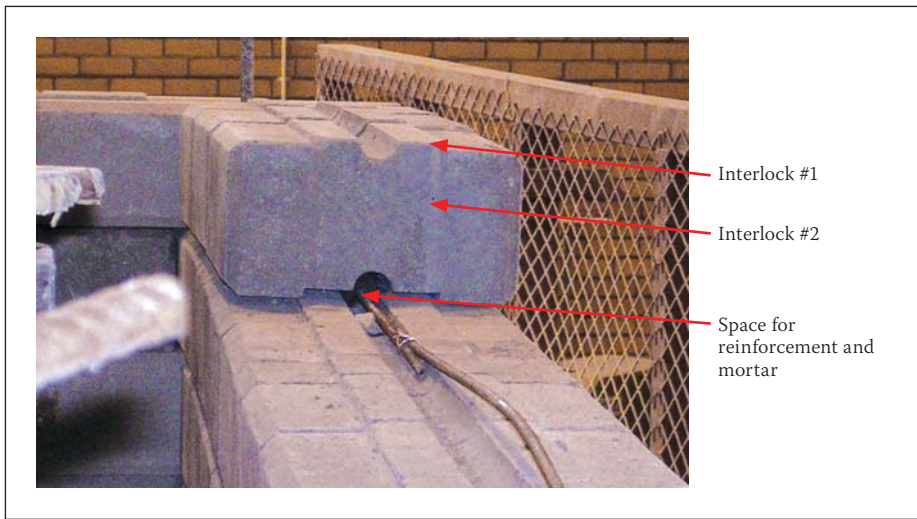
**Figure 2** Details of one variety of Hydraform interlocking bricks

The test structure's walls were made of 7 MPa Hydraform (2009) bricks. Two varieties of bricks were used. Both had interlocking keys in two directions, but only one variety also had a conduit space for reinforcement bars and mortar (see Figure 2). In the test structure, the interlocking bricks were dry-stacked and the only reinforcement used was as shown in Table 1 and Figure 3. Note that the reinforcement consisted of one bar per conduit space between the bricks, embedded in mortar, and placed only at certain locations in the test structure. In addition, a 75 mm deep, 15 MPa, concrete ring beam with two Y12 reinforcement bars, and Y6 stirrups spaced every 150 mm, was cast at the top of the structure. The reinforcement pattern (Figure 3) shows that the structure was tied together along its perimeter: (a) just below the window and (b) at the level of the eaves.

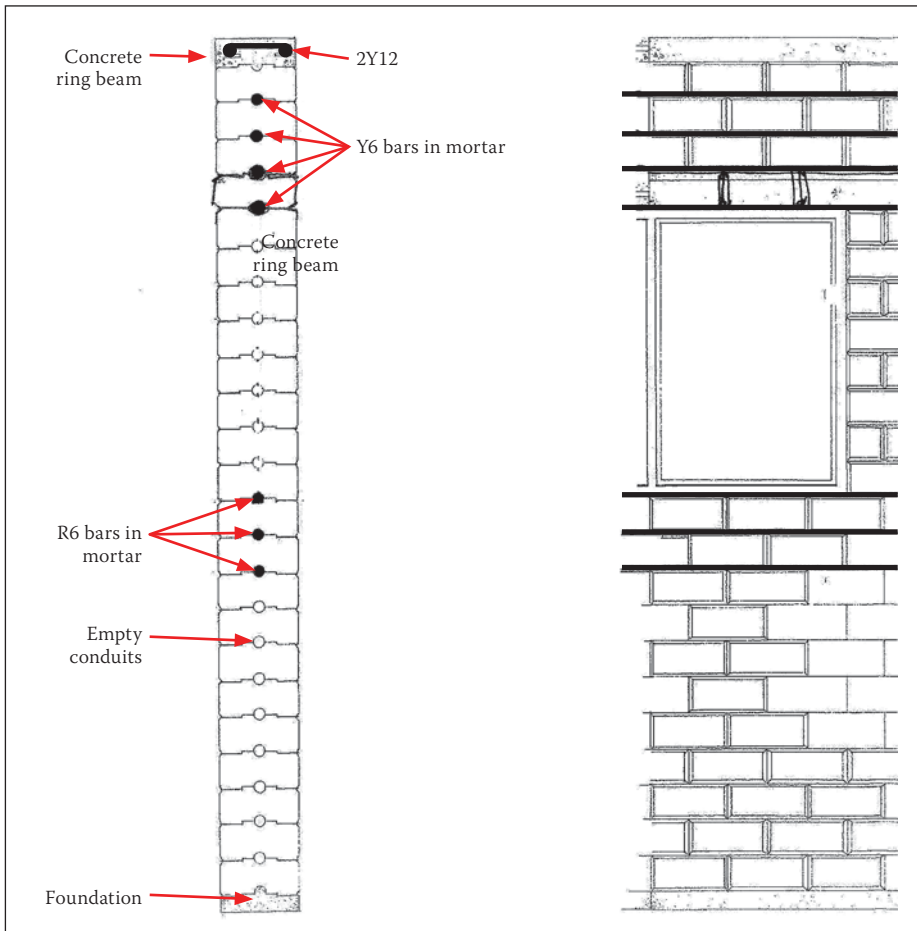
**Figure 3** Cross-section and elevation segment of the wall of the test house showing position of horizontal reinforcement

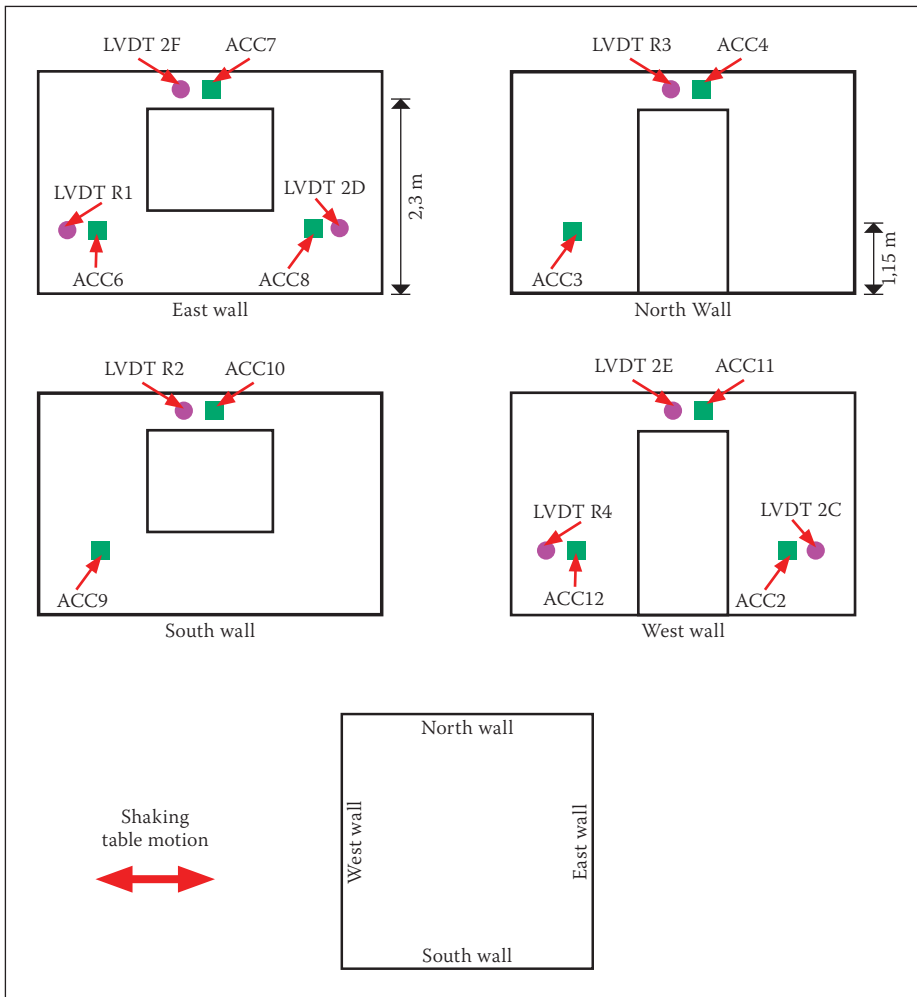
**Figure 4** Sensor positions on the test structure, together with sensor type and identification. All views are from inside the structure looking out. The squares represent the accelerometers and the circles the LVDTs

The test structure was instrumented with two types of sensor: nine  $\pm 5$  g accelerometers (ADXL105JQC by Analog Devices Inc) and eight LVDTs of various stroke lengths. All sensors were placed on the inside of the structure with their measuring axes perpendicular to the wall to measure out-of-plane behaviour. Special care was taken to protect the sensors in steel enclosures from flying debris. Despite this precaution, several sensors were severely damaged. The positions of all active sensors and their identifying numbers are shown schematically in Figure 4. The sensors were positioned at 2,3 m (referred to as "top") and 1,15 m (referred to as "mid") above the top surface of the shake table. The LVDTs were attached to a stiff steel instrumentation frame, which

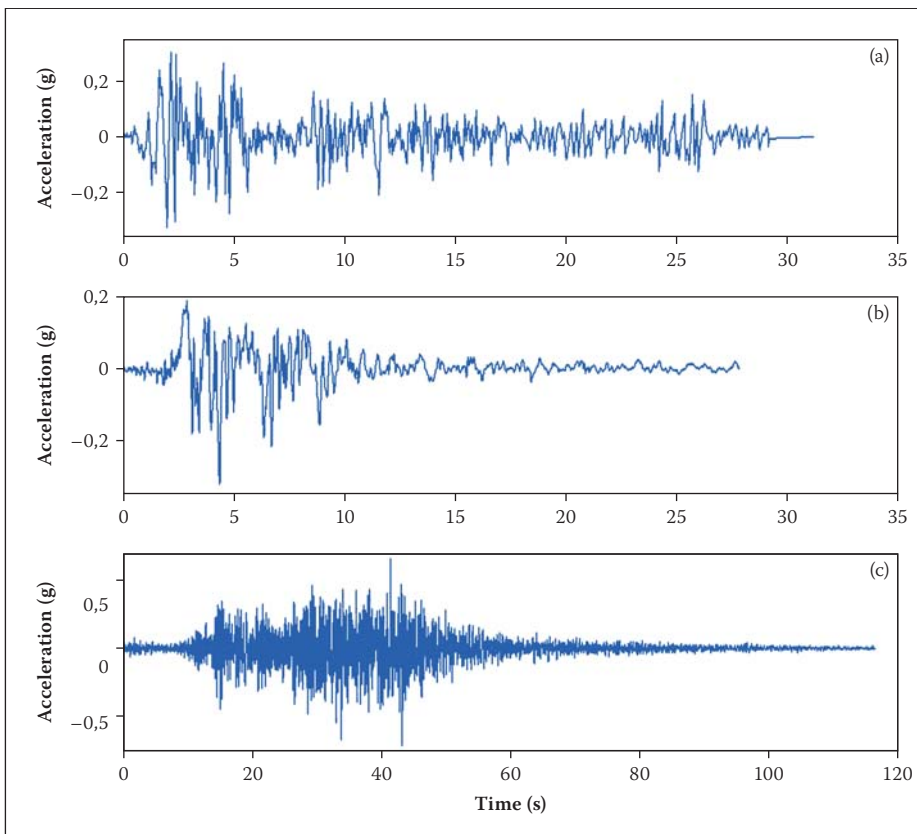
**Figure 5** Acceleration time histories of: (a) El Centro earthquake, (b) North Ridge earthquake, and (c) Lolloe earthquake. Note the different time and acceleration scales

The three earthquakes that were considered were: (a) the El Centro earthquake of 1940, (b) the North Ridge earthquake of 1994, and (c) the Lolloe earthquake of 1985. The acceleration time histories for these earthquakes are shown in Figure 5. Table 2 gives some statistics of these earthquakes.

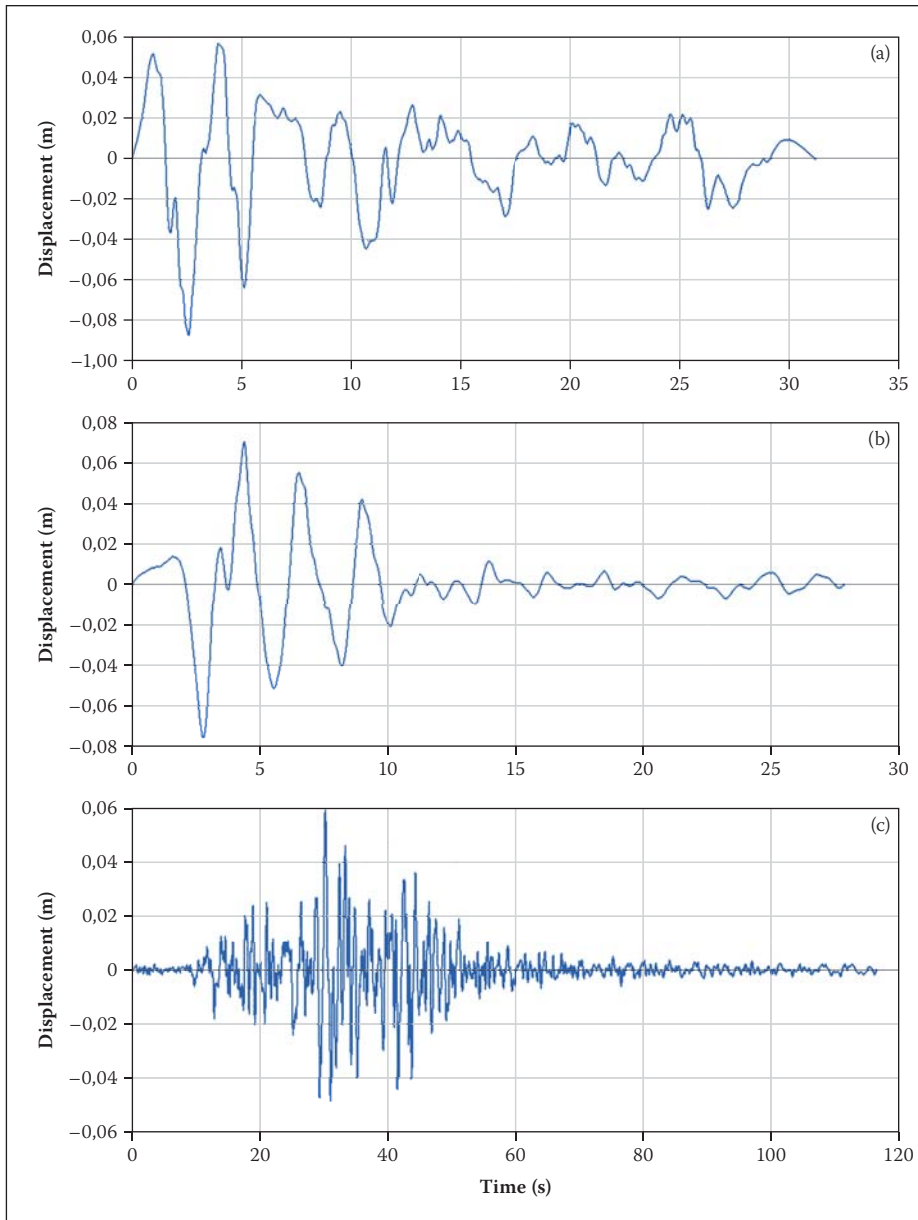
**Figure 6** (a) Filtered El Centro displacement history (2 s moving average time window), (b) Filtered North Ridge earthquake displacement history (1,125 s moving average time window), (c) Filtered Llolleo earthquake displacement history (1,125 s moving average time window) (after Elvin 2009)

The usual control parameter for servohydraulic test machines is displacements. To obtain the displacement time histories of the earthquakes, the acceleration traces were double-integrated numerically using the trapezoidal rule (see Elvin (2009) for details and discussion). The resulting histories showed that the range of displacements of each earthquake was large, falling well outside the range of the 150 mm stroke of the Transnet Facility actuator used. The displacement histories were high-pass filtered using the moving average approach, as described in Elvin (2009), to produce the time sequences shown in Figure 6. As can be seen from this figure, the filter was designed so that the displacements of the three earthquakes were within the stroke range of the actuator.

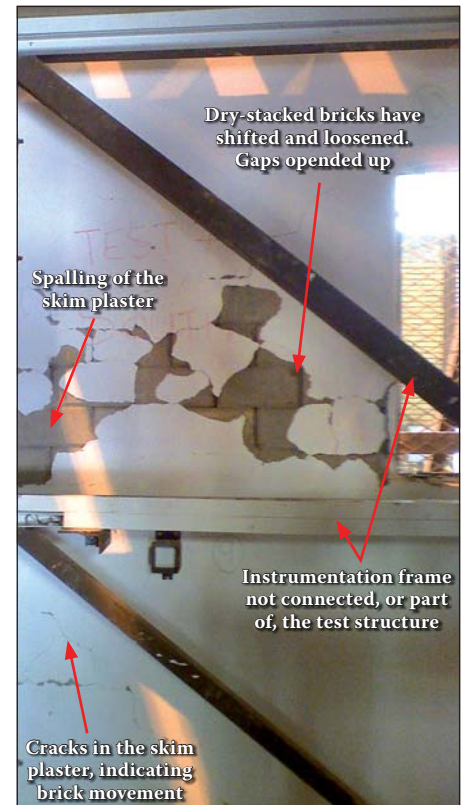
**Figure 7** Partial spalling and cracking of the skim plaster on the south wall of the test structure after the first filtered Llolleo earthquake was applied. The view is from the inside of the test structure

only microcracks in the skim plaster. As shown in Figure 7, the Lollole earthquakes produced significant spalling of the skim plaster and brick loosening. In addition, the second Lollole earthquake caused the gaps between the dry-stack bricks to grow and produced vertical cracks in several bricks (i.e. split the bricks). The damage started from the windows and doors, i.e. from the weak points in the structure. In general, however, the test structure was only mildly damaged by the sequence of four earthquakes and the house still had sufficient structural integrity to allow occupants to exit safely. It is estimated that after all the earthquake simulations, the damage to the test structure can be classified conservatively as Grade 2 damage on the European

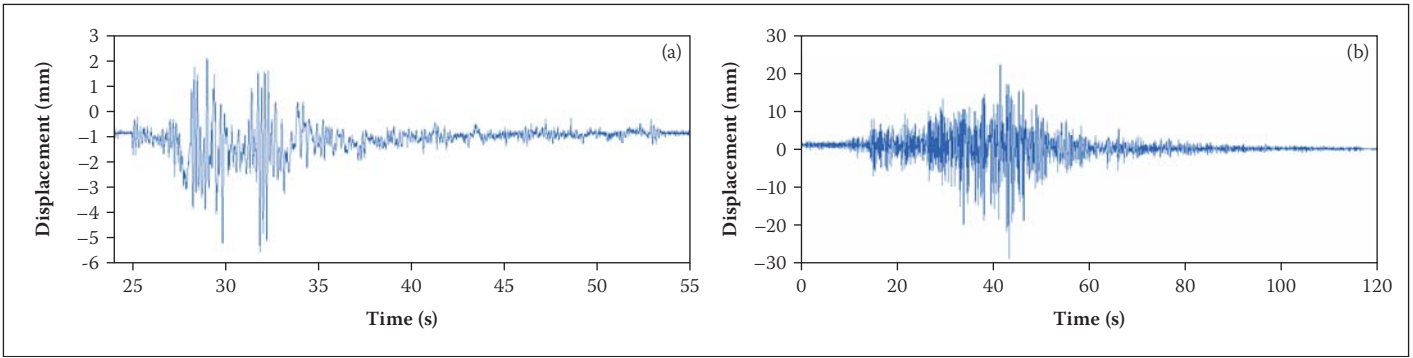
**Figure 10** Displacement at the top of the west wall during: (a) the North Ridge earthquake, and (b) the first Llolleo earthquake

To emphasise the strength of the Llolleo earthquake, Figure 10 shows the deflections at the top of the west wall during the North Ridge and the first Llolleo earthquakes.

The sensors showed that for all the earthquakes considered, the out-of-the-wall-plane permanent deflections were small compared with the wall thickness (see Table 5 for the maximums). This indicates that the structure was either fully elastic or almost elastic. The maximum deflections (Table 5) for the North Ridge earthquake caused only minor observable damage (in the form of micro-cracks in the skim plaster). After the larger El Centro and Llolleo earthquakes, the sensors showed that larger deflections perpendicular to the plane of the walls did occur. As an example, Figure 10 shows that the top of the west wall deflected ten times more for the

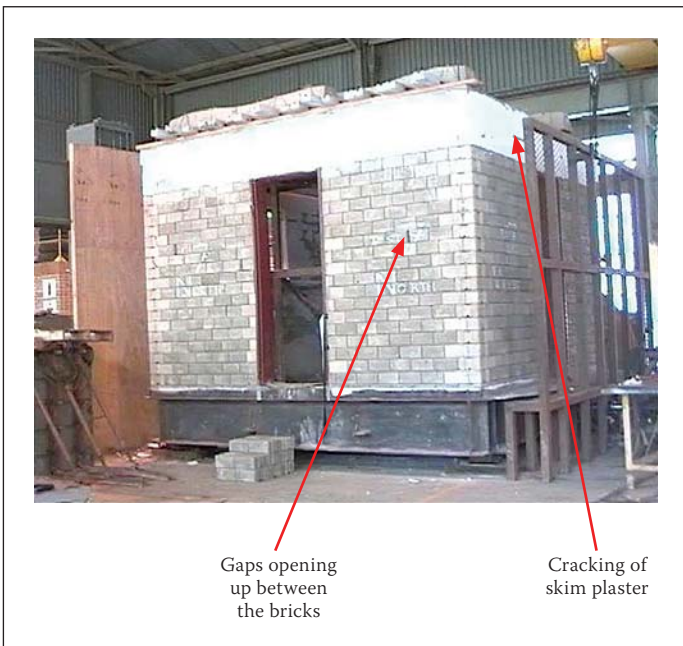
**Figure 11** North and west walls of the structure after the harmonic 9 mm amplitude, 5 Hz base excitation

ground motions after the earthquake sequence. The first harmonic base excitation of 9 mm at 5 Hz, which was close to the previously measured *undamaged* structure's natural resonant frequency (Mofana & Rathebe 2005), produced the damage shown in Figure 11. It is estimated that the damage was of Grade 2 on the European Macroseismic Scale (1998).

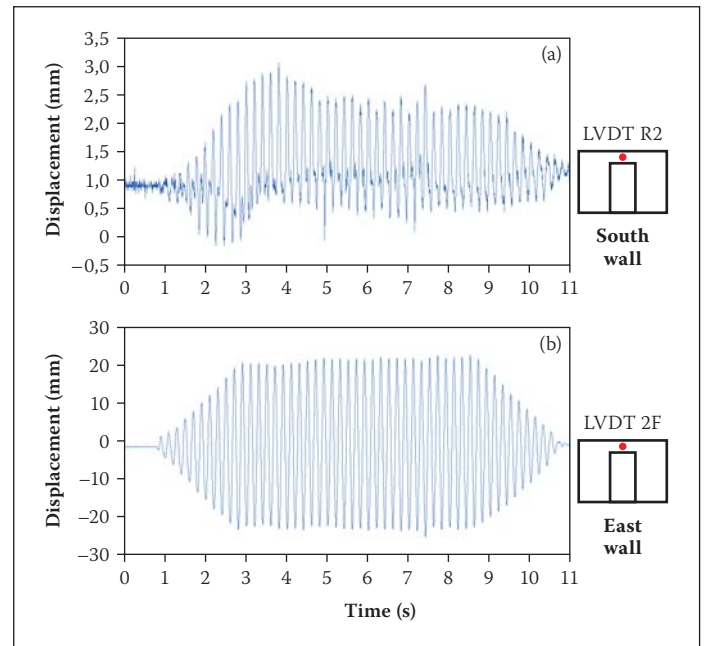
**Figure 12** Displacement of the top of the west and east walls during 5 Hz sinusoidal base excitation

As expected, the sensor readings showed periodic responses (due to the periodic base excitation). This can be seen in the typical results of Figure 12. Depending on the location, the sensor response (both displacement and acceleration) showed a base frequency of 5 Hz, with higher superimposed frequencies. The maximum displacements (24,47 mm) and maximum accelerations (2,71 g) measured

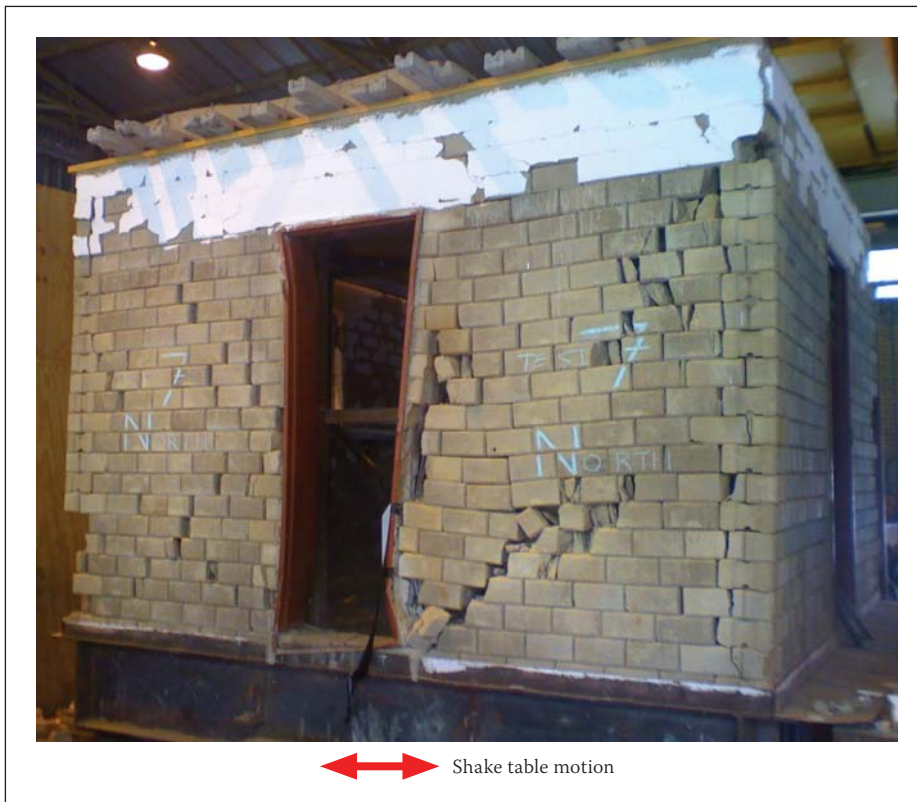
**Figure 13** Damaged test structure showing the north wall after the base had been subjected to a 22 mm, harmonic 3 Hz motion for 15 seconds

The second harmonic ground excitation of 22 mm and 3 Hz, which was close to the *damaged* structure's natural resonant frequency (Mofana & Rathebe 2005), resulted in extensive damage, as shown in Figure 13. Although the structure was still standing, the structural integrity had been compromised. The dry-stack bricks had shifted significantly and many had cracked, split, been crushed or were even missing. Note that the predominant damage had occurred in the two walls that were aligned with the direction of the earthquake.

Despite the severe damage, the mass representing the roof was still being carried by the structure and would-be occupants could have left the damaged structure unaided. The steel doorway in Figure 13 not only deformed plastically (thus dissipating energy), but also contained the dry-stacked blocks. Most importantly, the doorway remained open. It was estimated that the damage is of Grade 4 on the European Macroseismic Scale (1998).

displacement. As can be seen in Figure 13, although there was substantial structural damage in the form of the characteristic “X” cracking in the north and south walls, the building remained standing. The reason for this is that a large portion of the input energy was absorbed and dissipated in first shifting, then cracking and finally crushing the bricks in the wall planes (north and south walls), until significant gaps had opened up. Video analysis also showed that bricks can move a large fraction of their lengths with respect to their neighbours. This results in large damping due to the inter-brick friction which bounds the displacements and accelerations, despite the base excitation being close to the natural frequency of the damaged structure.

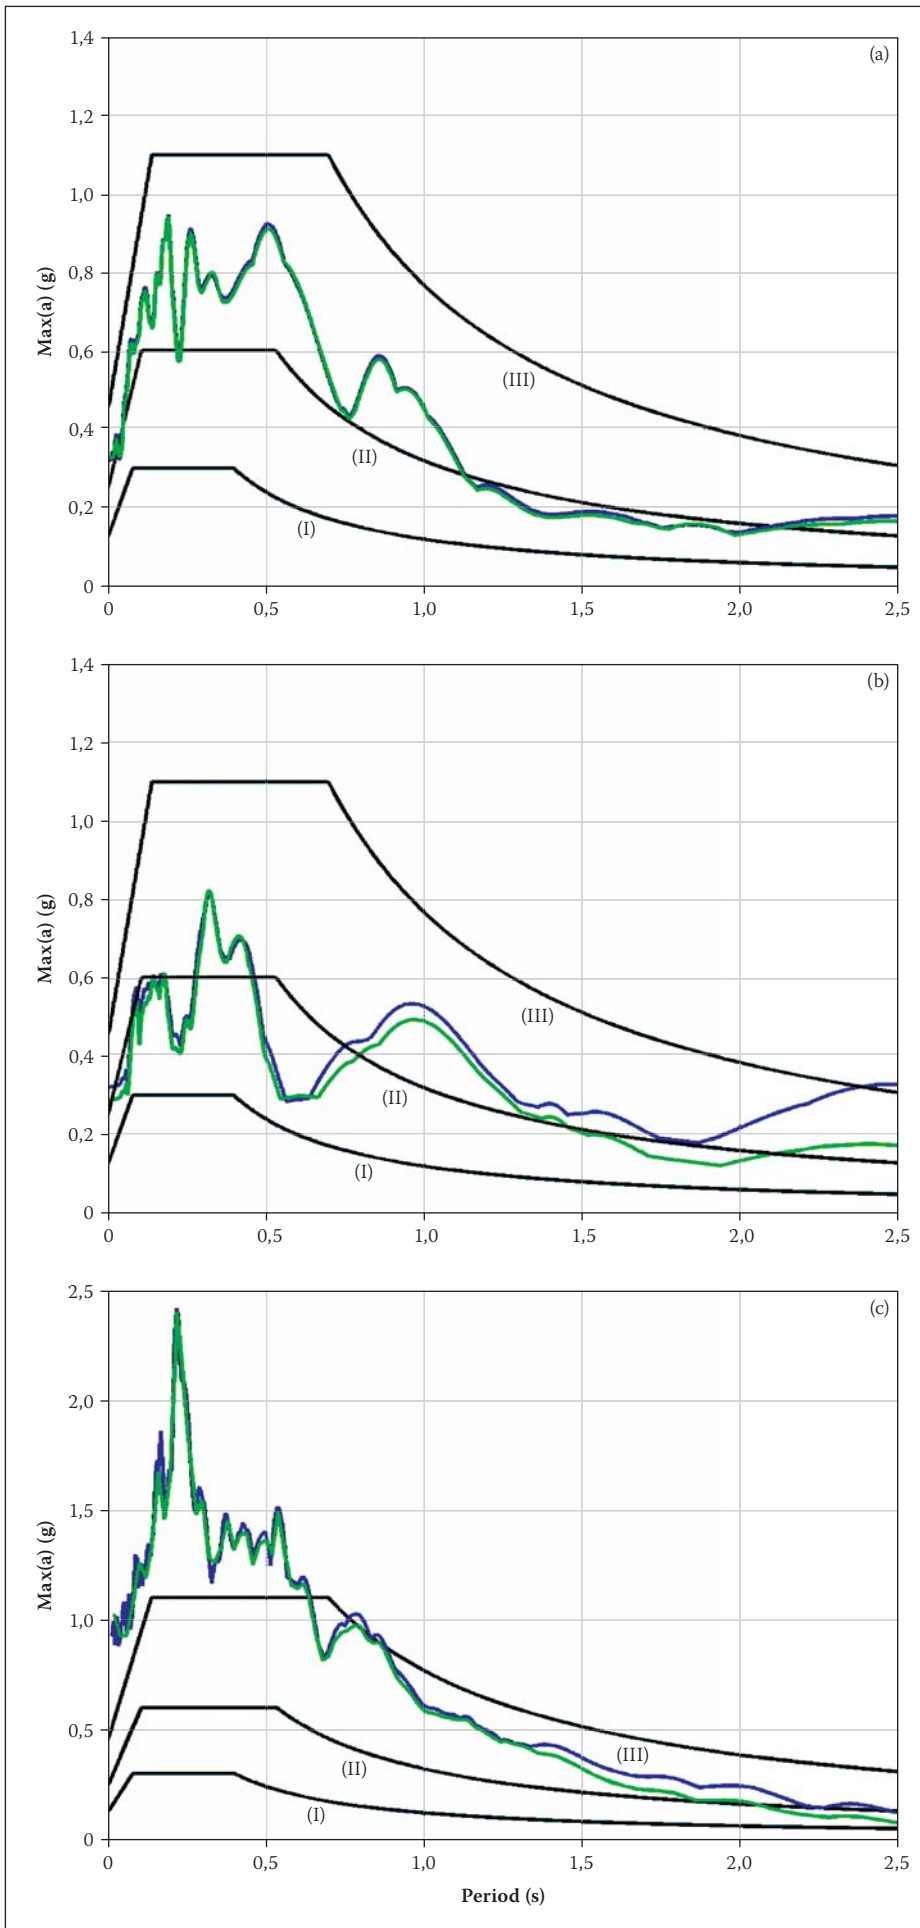
**Figure 14** Response spectra for: (a) El Centro; (b) North Ridge; and (c) Llole. The lines correspond to the original earthquake signals (blue) and the filtered signals (green). The black lines are the Uniform Building Code (1997) design spectrum earthquakes (after Elvin 2009)

The response spectra for the El Centro, North Ridge and Llole earthquakes were constructed as explained by Elvin (2009). Both the original and the filtered signals were used, with an assumed damping ratio of 5%. The results are shown in Figure 14.
