# Introduction of drill and blast utilizing pneumatic rock-drills in a Rwandan artisanal underground mine

by T.A. Sethu\*, T.P. Letsebe\*, L. Magwaza\*, and S.M. Rupprecht\*

Paper written on project work carried out in partial fulfilment of BTech (Mining Engineering) degree

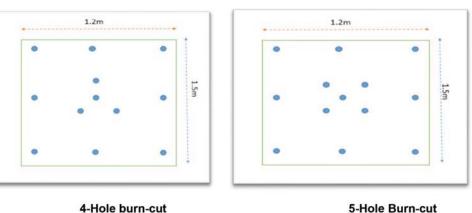
#### 4-Hole burn-cut

Figure 2-Development round utilizing a 4- or 5-hole burn cut

The plan to transform the current 'artisanal' development practices into 'small-scale' development focused on the proper marking and drilling of the blast-holes and the proper charging and timing of the blast round. The initial development blast pattern for the 1.2 m by 1.5 m raise was based on a 15 blast-hole pattern. Based on the rock conditions and observed fragmentation the blast round was modified to a 13-hole pattern. Subsequently, the 5-hole burn cut was reduced to a 4-hole burn cut (Figures 2 and 3) with no adverse effects on the blast advance or fragmentation. During this period the local foreman was identified as 'champion' and was trained in the marking-off of the development round, taking line and grade, the proper methodology of charging the blast-holes, and the correct sequencing (timing) of the blast-holes utilizing safety fuses.

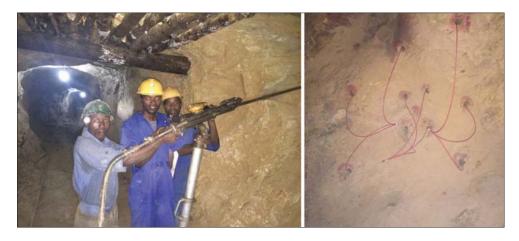
Figure 3-Underground rock-drilling and completed development round (11 holes) utilizing a 5-hole burn cut

trained on a week-long course provided by Atlas Copco. The biggest hurdle, and one which still remains, is the concept of creating a free-breaking face through the use of a burn cut. When left unsupervised the miner would attempt to charge the 'free hole' or do away with the burn cut completely. Figure 4 depicts the total time for load and haul activities based on the time study results shown in Table I. The analysis of the data highlights the following issues that affected the overall efficiency of the load and haul cycle.
